ASR Well System

Hydrology of the Peace River

The Peace River is our Source Water

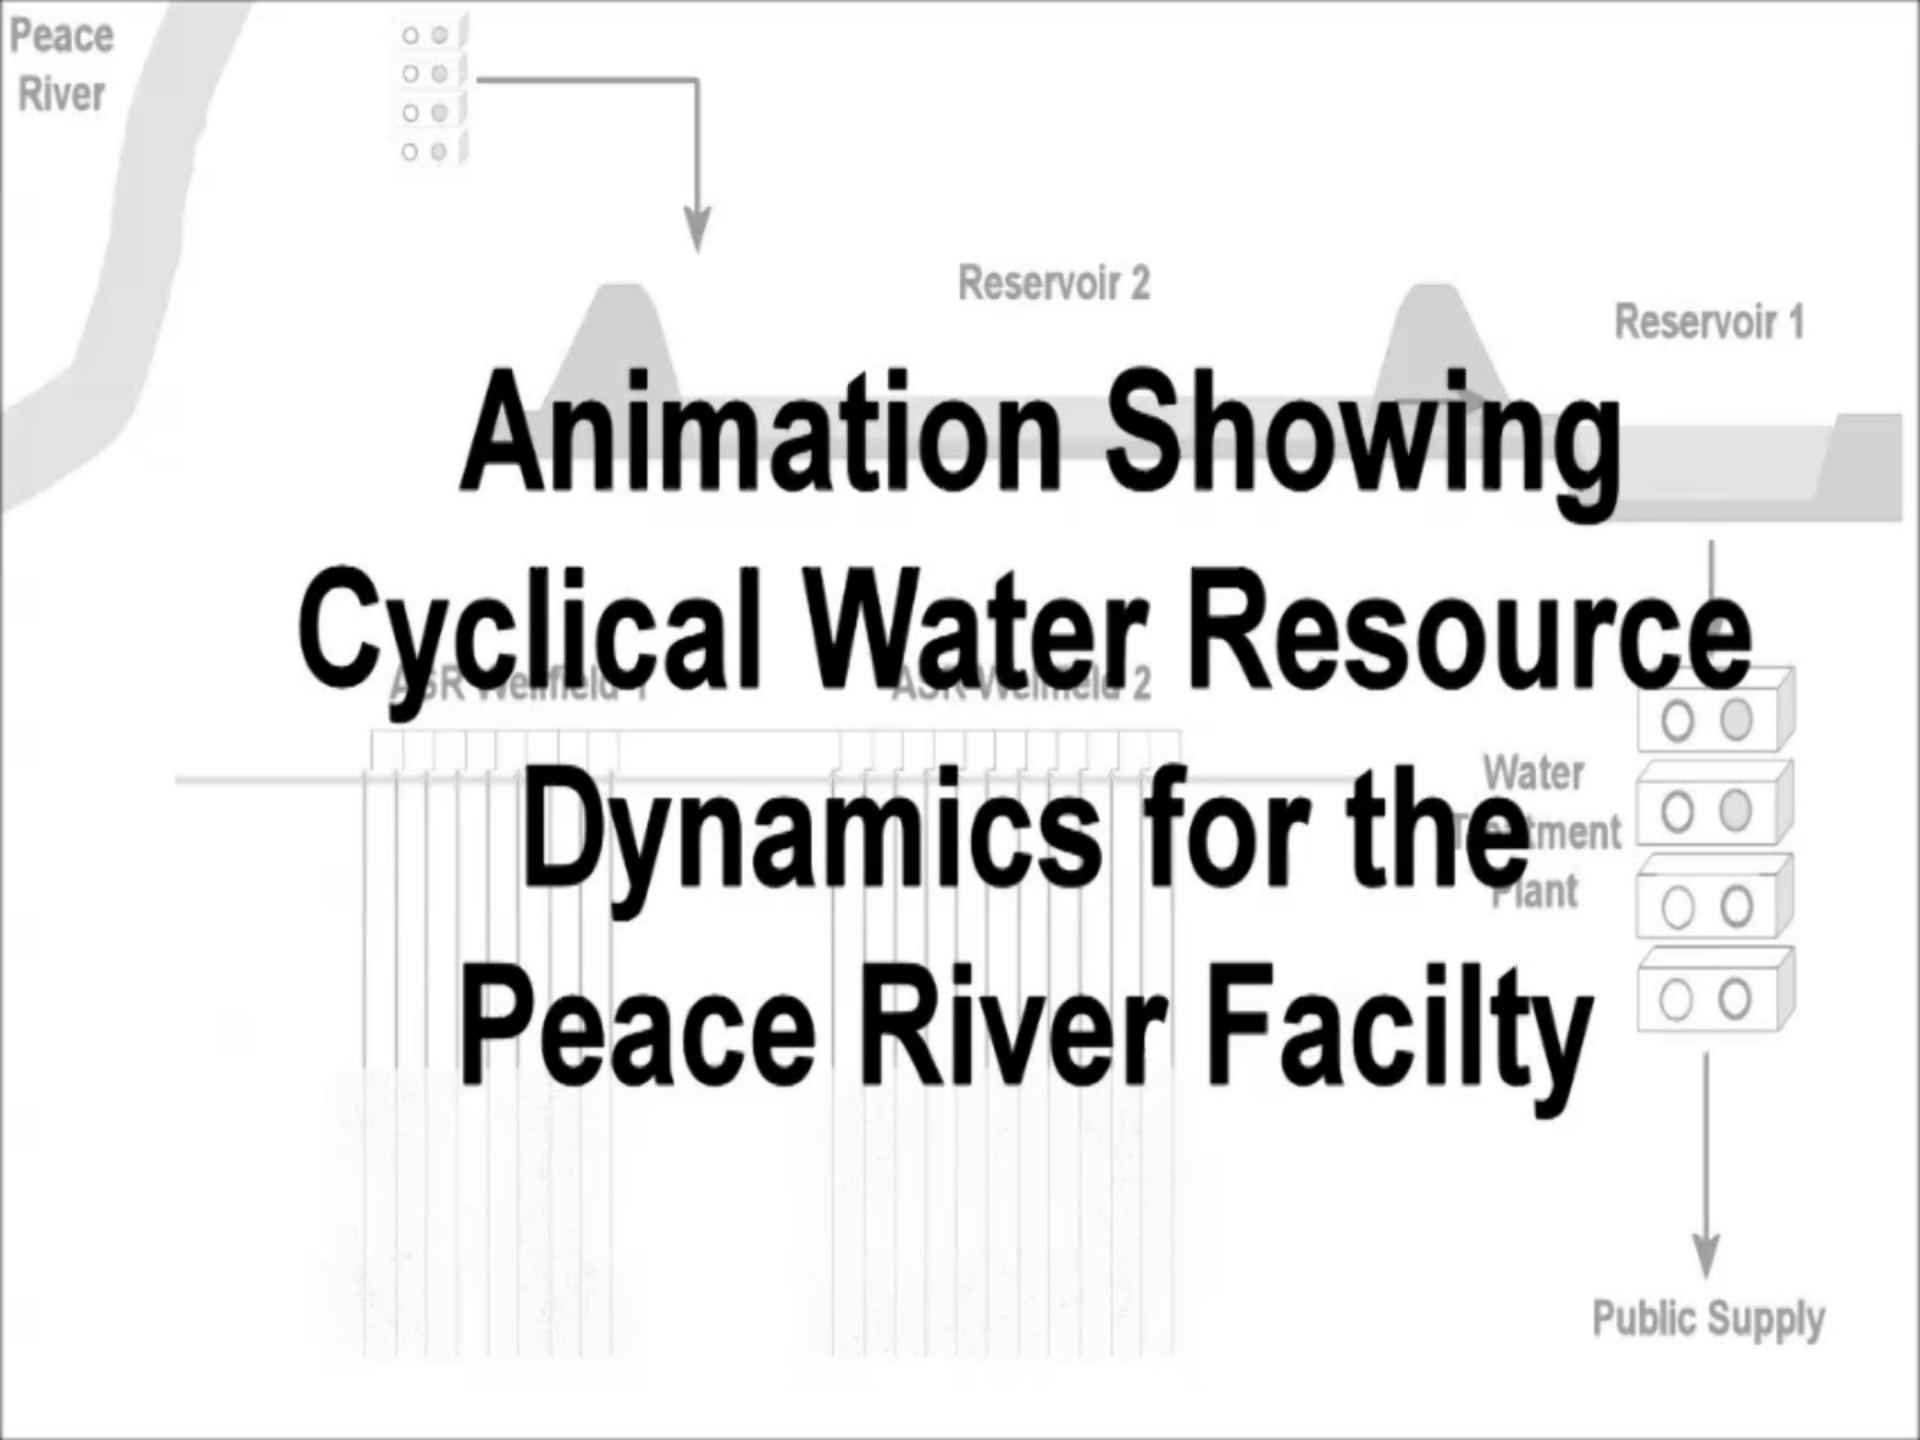
Animation Showing Cyclical Water Resource Dynamics for the Peace River Facility

ASR Wellfield 1

ASR Wellfield 2

Water Treatment Plant

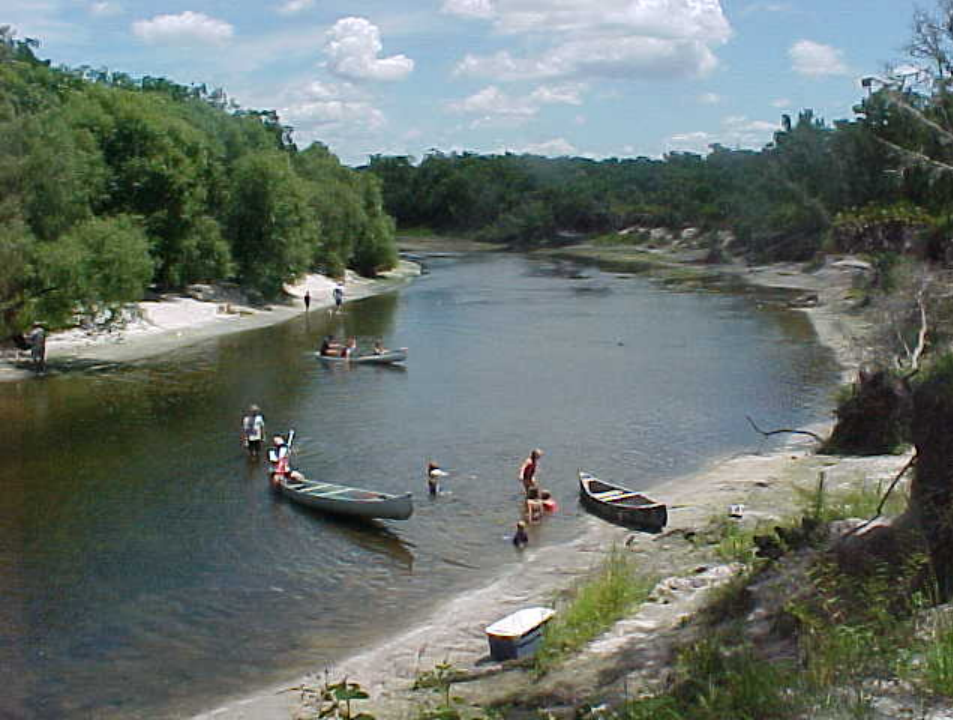
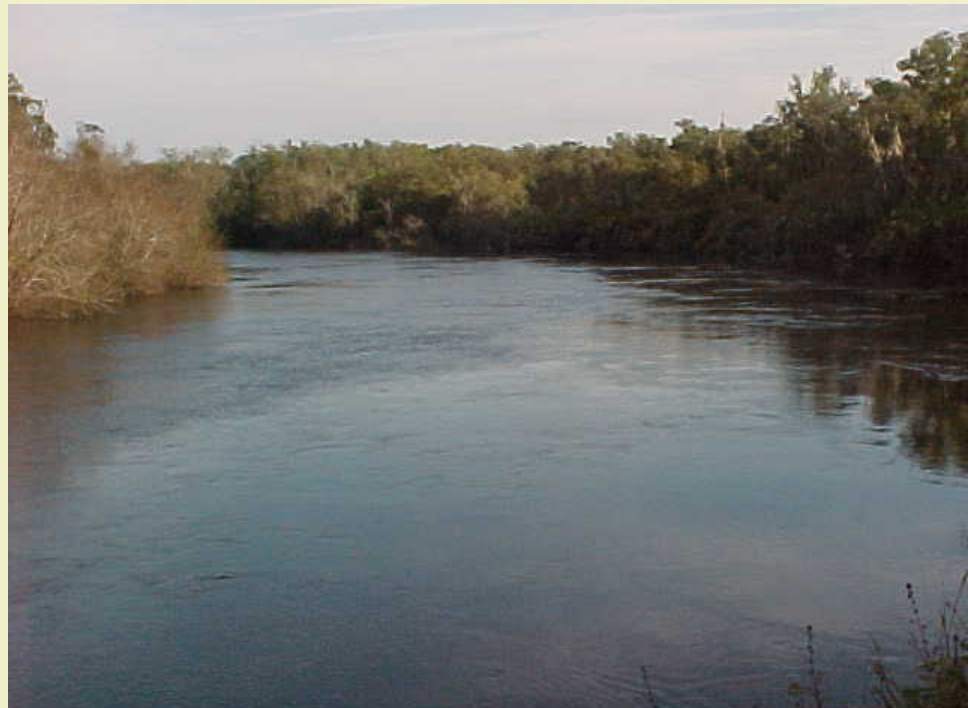
**The Peace River near
Arcadia - typical dry and
wet season views**

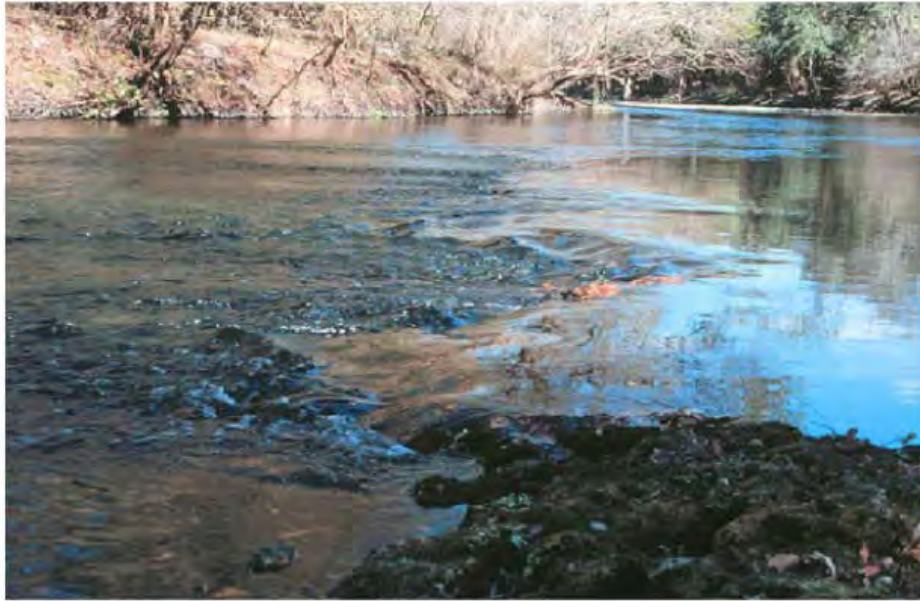
Figure 7-4.

Historically, the upper Peace River flowed year-round in all but the driest years.

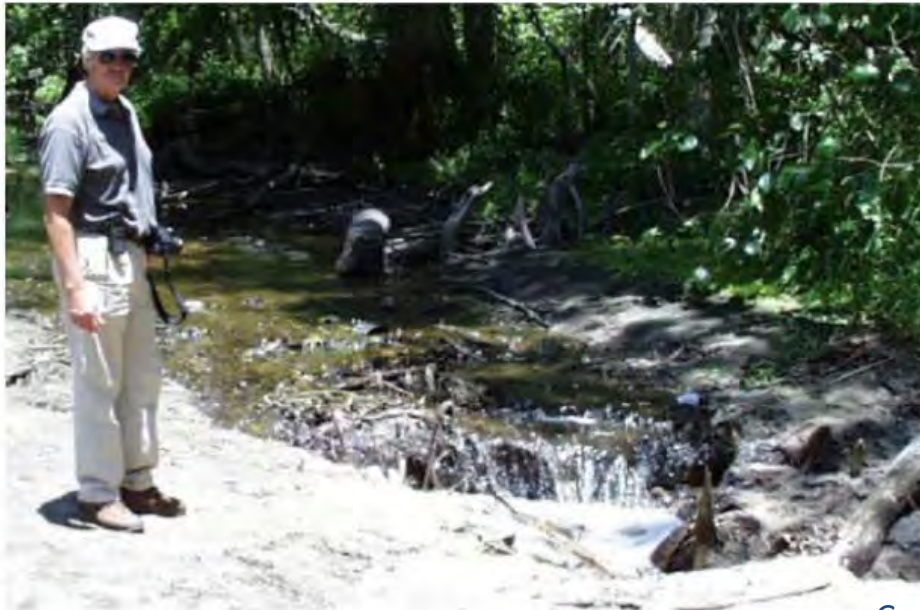
Figure 7-5.

Excessive groundwater withdrawals and hydrologic alteration from urban, agricultural and industrial development in the upper Peace River watershed have resulted in the river often completely disappearing into sinkholes or not flowing at all.

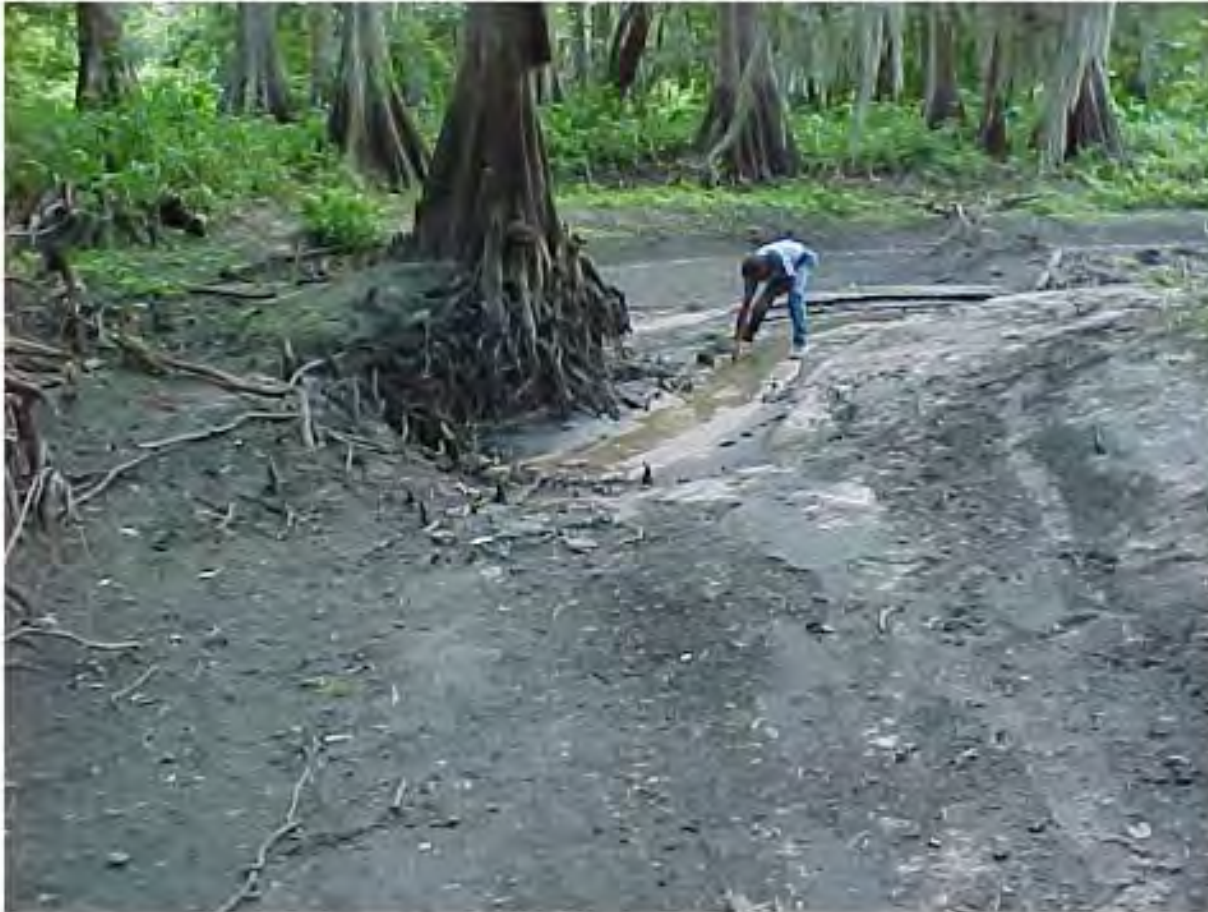
Figure 7-17.
Peace River flowing into
sinkhole near Bartow
Wastewater Treatment
Plant, May 2001.

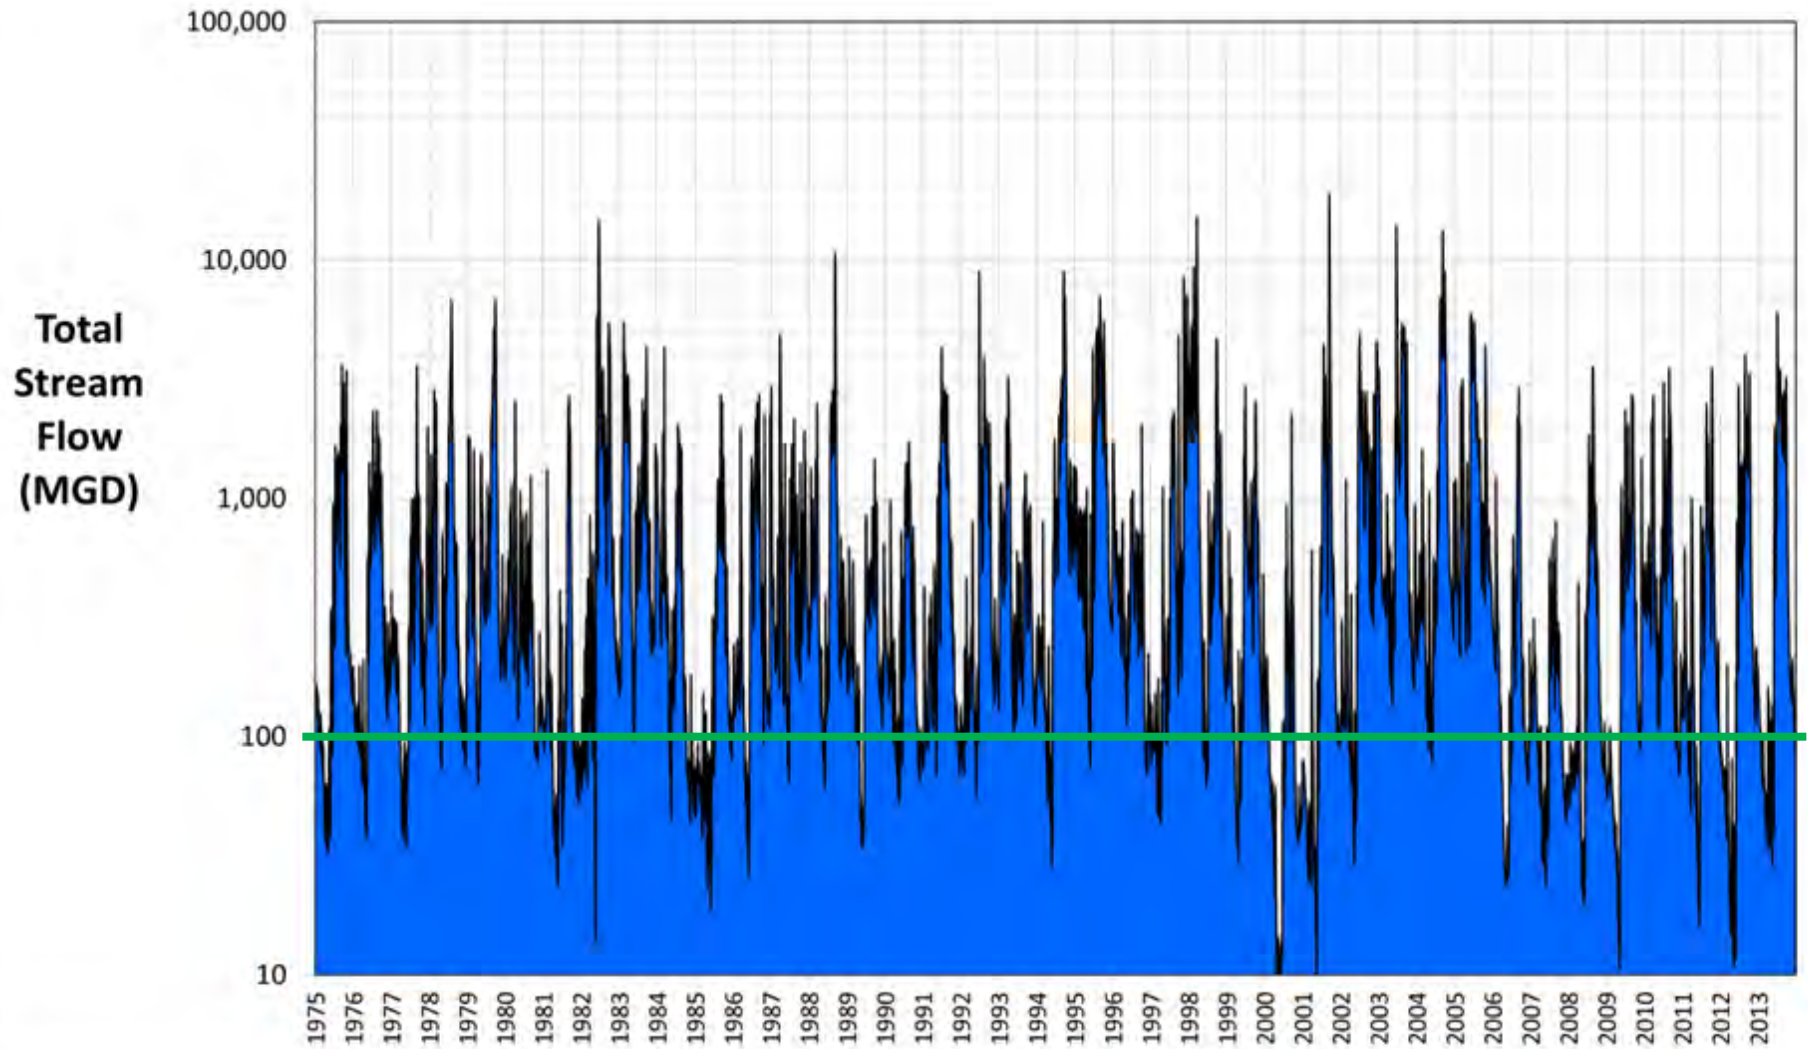
- River flows vary dramatically (8 Mgd – 18 Bgd)
- Three orders-of-magnitude!

Total River Flow

2000-01 Drought is Our Challenge Event
